**AIRCRAFT
ACCIDENT
REPORT**
Trans World Airlines Flight 800
Part I
Consideration of Reasonable Probable Causes

Report on the accident to
Trans World Airlines Flight 800
Boeing 747-131, N93119
Near East Moriches, New York
July 17, 1996
by John Barry Smith,
Independent Aircraft Accident Investigator

Part I: Consideration of Reasonable Probable Causes

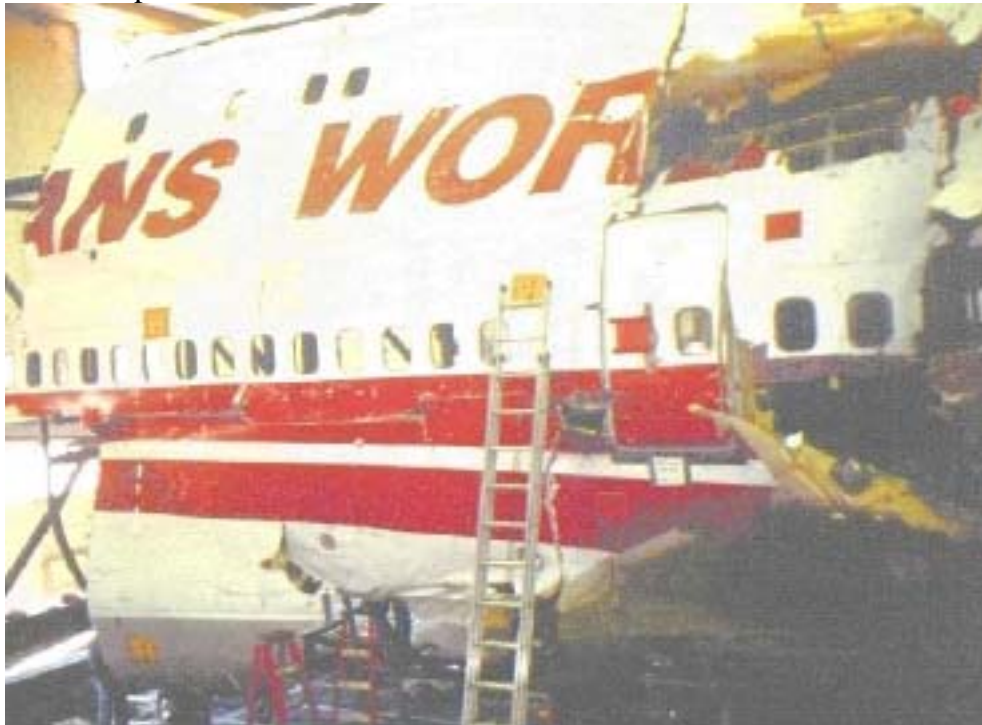
The left front of the reconstruction at LF4

Nose to left.

A CWT fire/explosion would be spherical, not directed, and would produce equal damage on both sides of the fuselage of TWA 800. However, the wreckage reconstruction shows smooth skin with little damage forward of the wing on the port/left side yet severe, shattered, torn, and frayed damage on the starboard/right side of the fuselage in the cargo door area. A CWT fire/explosion would not cause unilateral damage on starboard side only, as can be seen.

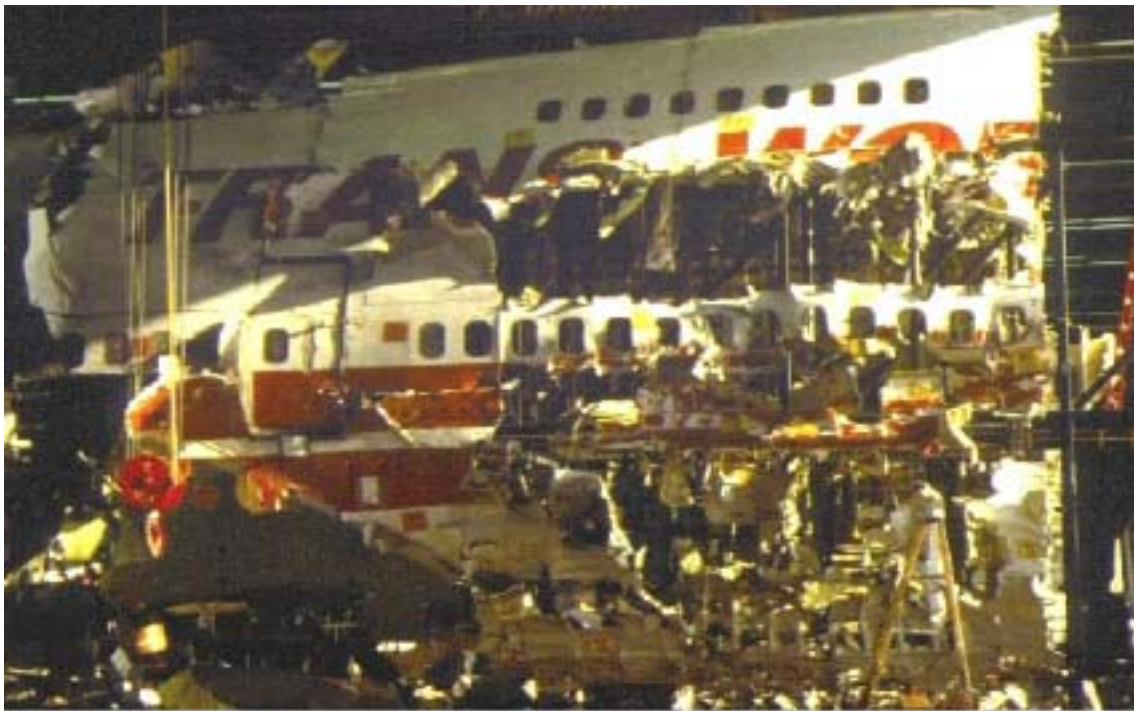
Right front of the plane

Nose to right.

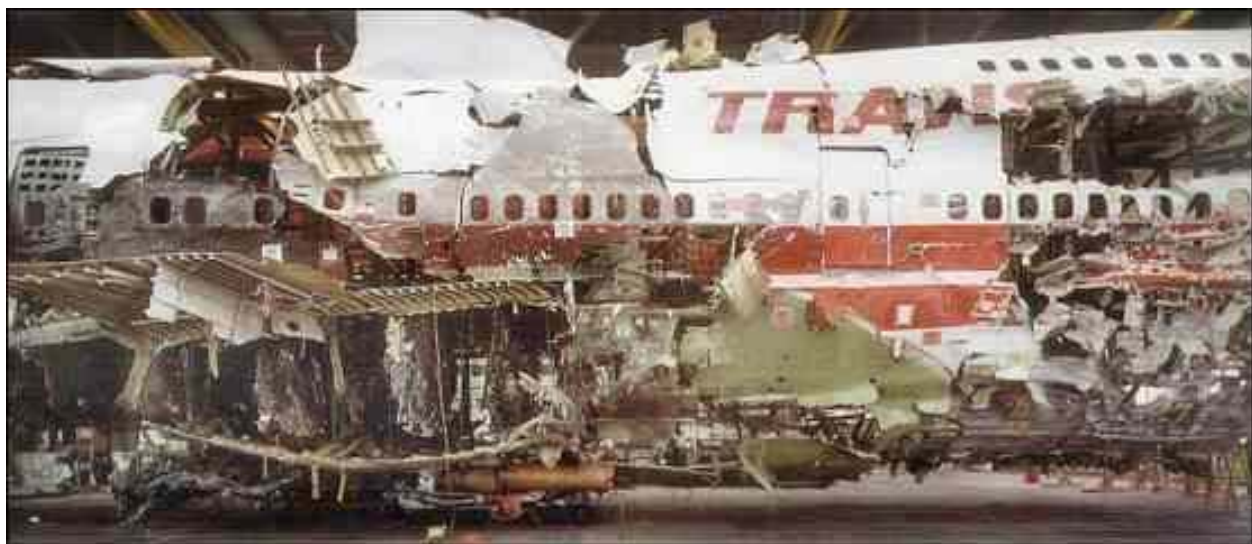
Right front and middle of Trans World Airlines Flight 800 revealing sharp sooted and non sooted cut in fuselage, nose to right.

The corroborative evidence required to be present for the CWT fire/explosion to be the secondary event would be a clean cut of a sooted and a not sooted area at the separation point of the forward section of the fuselage, non burned passengers, the sudden loud sound at initial event time to be some other source than a fuel/air explosion, an ignition source determined, unilateral damage to engine number three, unilateral damage to the starboard side of the fuselage, and the first pieces to depart the aircraft were from just forward of the wing. That evidence was present.
